## Distribution Systems Corrosion Control Aids Residuals

by Y. Koby Cohen, Calvin G. Abernathy, and Christopher P. Hill

# Corrosion Control Aids Residuals

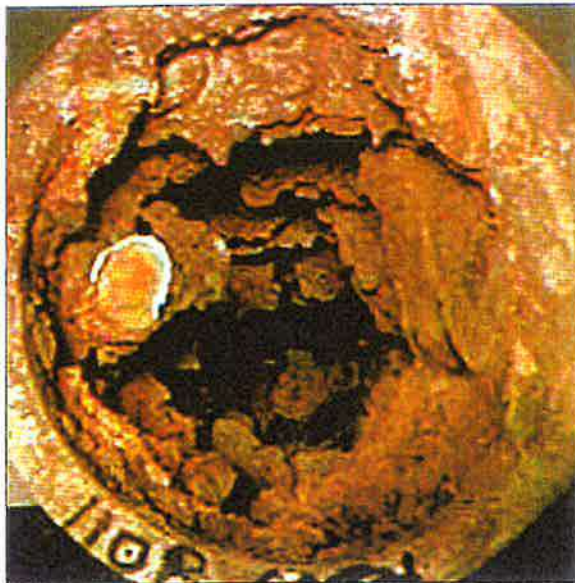
Corroded pipes comprise about 40 percent of the District's distribution system.

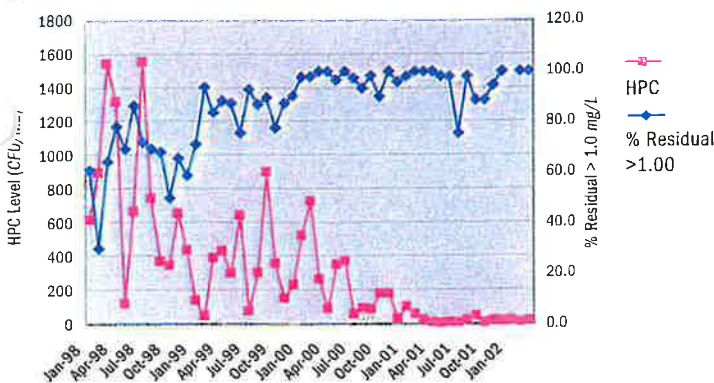
Figure 2. HPC vs. total chlorine residual level

*HPC bacteriological analyses.* HPC levels, which are the main indicator of bacterial activity in the study area, also decreased significantly following the addition of polyphosphate blend. However, it took almost two years for the level to consistently remain below 100 colony forming units/mL, which is the District goal. We suspect that initially the polyphosphate-blend

agent dissolves the corrosion product–biofilm matrix on the pipe wall, resulting in higher HPC levels. Throughout the study period, all bacteriological samples were absent of coliform bacteria.

For this system, a minimum of two years of polyphosphate-blend addition is required to establish low HPC levels. The length of time following polyphosphate-blend addition required to reduce HPC levels depends on the type and age of the water mains and characteristics of the biofilms and corrosion products. Newer systems, which may contain thinner biofilms or fewer corrosion by-products, may be able to reduce HPC concentrations in less time. Older systems that have unlined cast-iron and steel water mains with firmly established biofilms may require longer than two years (Figure 2).

with DPD-method procedures to determine if the District goal to maintain a total chlorine residual greater than 1.0 mg/L was being met. Prior to the addition of the polyphosphate blend, as few as 30 percent of monthly samples had a measured total chlorine residual greater than 1.0 mg/L. Approximately six months later, 90 to 100 percent of the residuals in the study area were greater than 1.0 mg/L. Also, less water was used in flushing to achieve the goal.
