## CCT Testing & Field Results Using SeaQuest in the City of Atlanta

The City of Atlanta performed two laboratory tests to evaluate SeaQuest against the baseline treatment of zinc ortho-phosphate. A pipe loop test using copper pipe & lead solder was performed in addition to a 30 day corrosion coupon loop test.

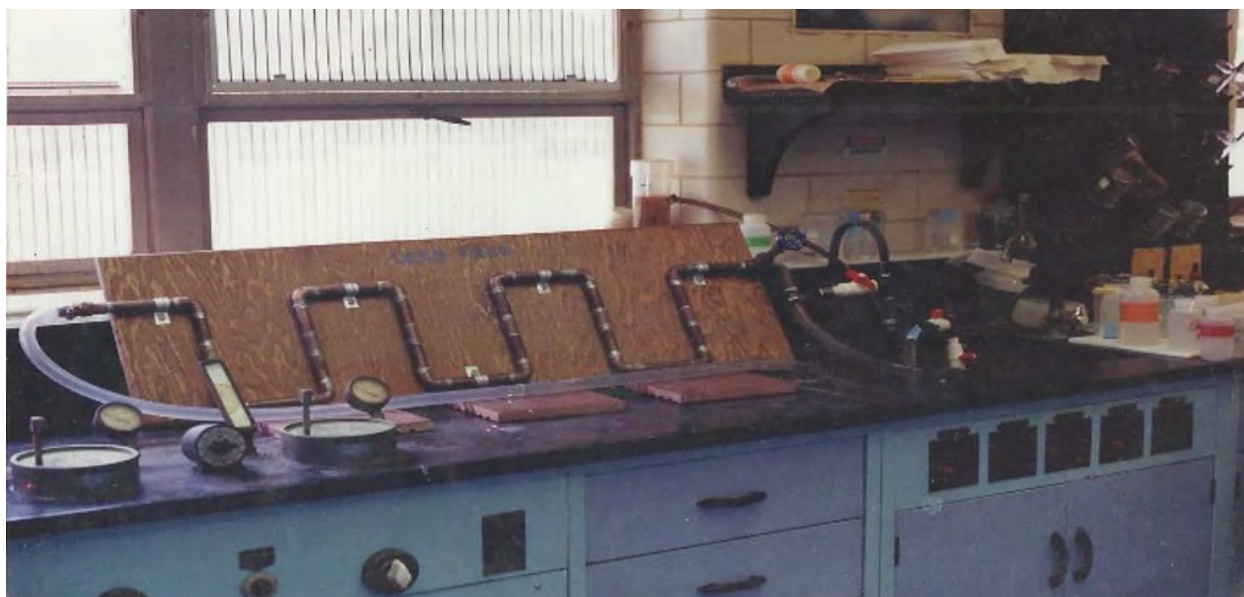
Image 1: Atlanta Pipe Loop Testing Apparatus

The pipe loop test was performed in two phases. Phase 1 was a 7-day test at the baseline conditions. Phase 2 was a 21 day test of the SeaQuest conditions. During the test the loop was rotated between running and stagnant conditions to simulate typical home use. Lead and copper results were measured in the water each day.

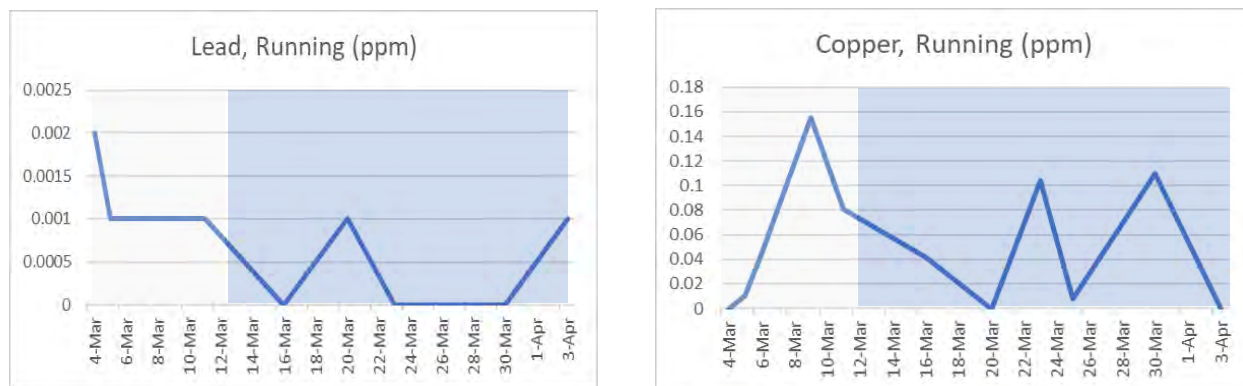
Figure 1&2: Running Pipe Loop Results; shaded blue = SeaQuest conditions

A slight improvement in both lead and copper release was observed in the running loop portion of the test, however both conditions yielded results well below the regulatory limits of 0.015 ppm and 1.5 ppm for lead and copper, respectively.

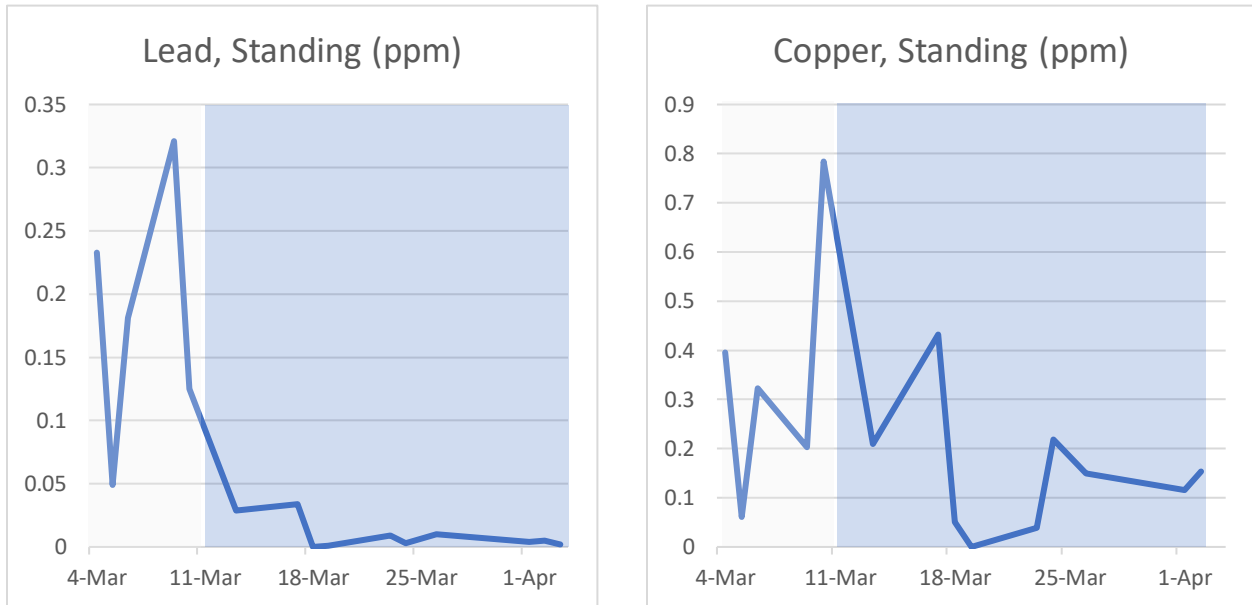
Figure 3&4: Stagnant Pipe Loop Results; shaded blue = SeaQuest conditions

As observed in Figures 3-6, during the stagnant loop portion of the test there was a severe contrast between the SeaQuest and control condition. In particular, the SeaQuest conditions resulted in stagnant lead release below the EPA threshold of 0.015 ppm. By contrast, the stagnant lead release of the zinc-ortho phosphate condition was well above the limit, at 0.18 ppm.

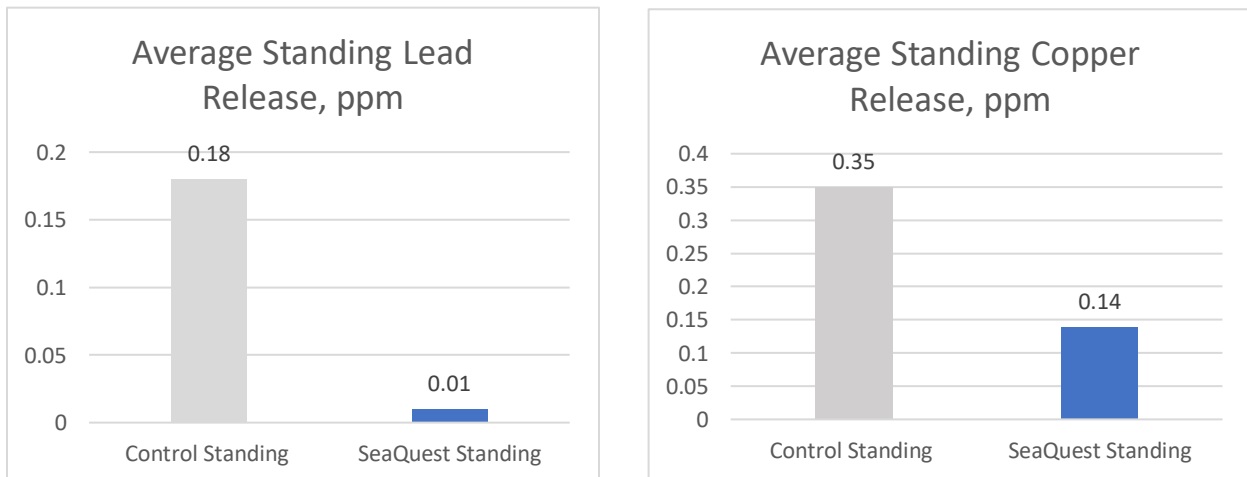
Figure 5&6: Stagnant Pipe Loop Average Lead Release

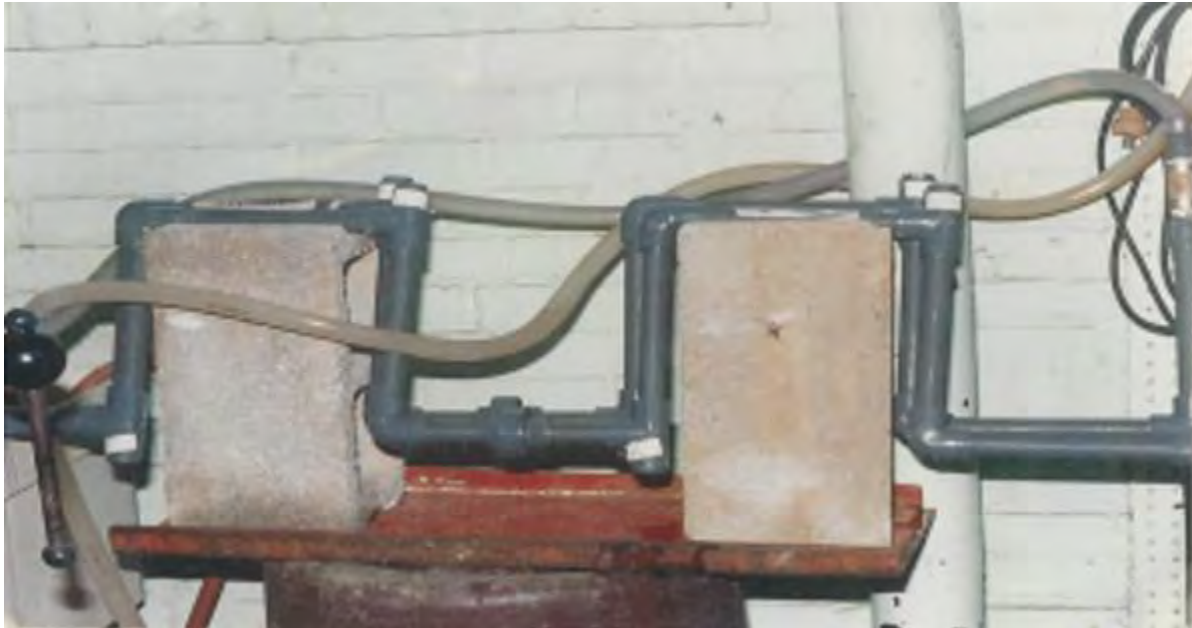
The second test performed was a single pass corrosion coupon loop. The loop was constructed from PVC and water was released into the lab sink. The baseline treatment was 2.0 ppm of zinc-orthophosphate at a pH of 7.5. The SeaQuest treatment was 0.45 ppm of SeaQuest at the natural pH of 6.4. The total hardness was 25 ppm. Each condition was tested for 30 days.

Image 2: Atlanta Coupon Loop Testing Apparatus

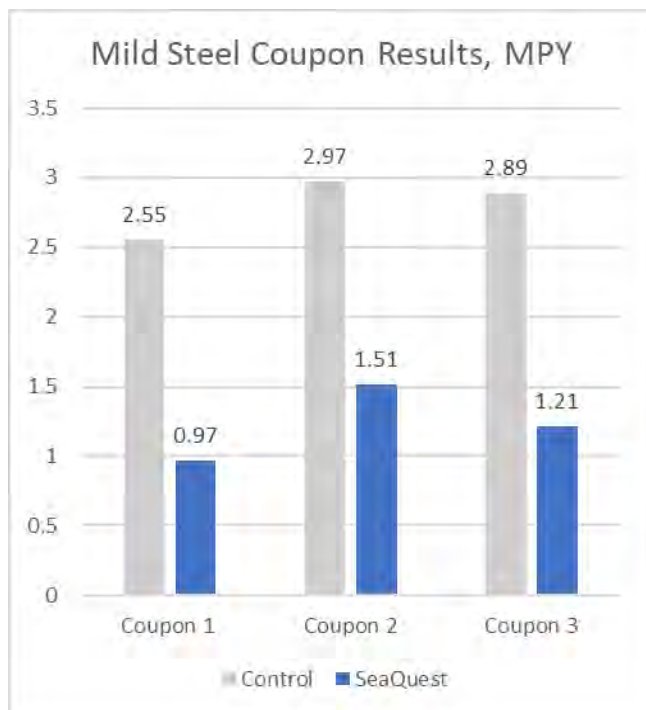
Similar to the results in the stagnant pipe loop, the results in the corrosion coupon test show significant performance differences between the SeaQuest and zinc ortho phosphate conditions. Three different coupons were used and all show consistent results. The average zinc ortho phosphate corrosion rate is 2.8 MPY. The average SeaQuest corrosion rate is 0.9 MPY.

Figure 7: Corrosion Coupon Results

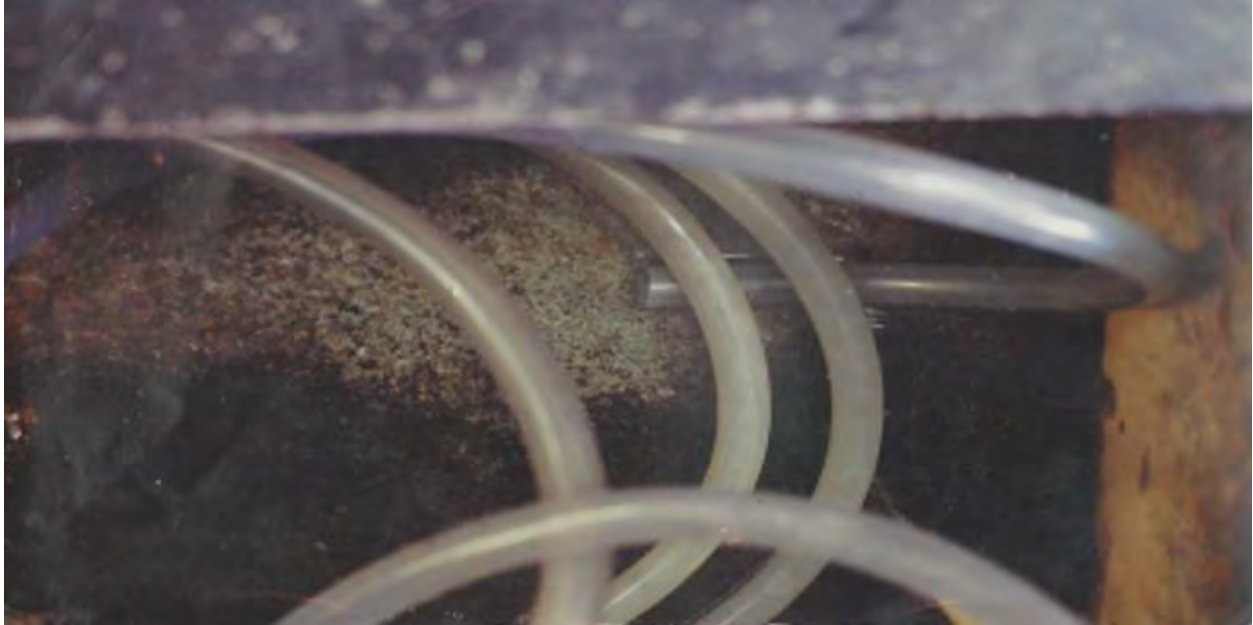
Image 3: Cleanup of Manganese Deposits in the Lab Sink

Towards the end of the test, a visible cleanup of the drain line in the lab sink was observed, as seen in Image 3. Based on this visual evidence and the positive test results showing the potential performance of the SeaQuest, a field trial was initiated.
