PIPE SCALE AND CORROSION REMOVAL WITH SEAQUEST

Case # 301 – Stellarton, Nova Scotia – May 2004 and Dec 2008
(Total Hardness <40 PPM; Fe 0.00; Mn 0.007; 0.630 MGD)

The 4" Distribution Pipe in the Town of Stellarton, Nova Scotia

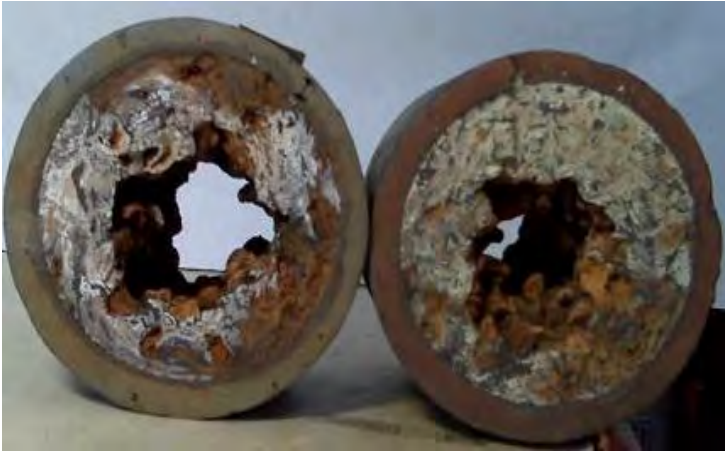
DECEMBER, 2008

MAY, 2004

1. In 1904, the Town of Stellarton, Nova Scotia, a Surface Water System, put new Cast Iron Pipe throughout their Distribution System. The 4" Pipe section above on the right was removed in May, 2004, about 100 years after it was put into the ground. The Stellarton Water Utility began using SeaQuest in 2004 and intended to cut out another piece of pipe 5 years later in May, 2009 for proof of cleanout.

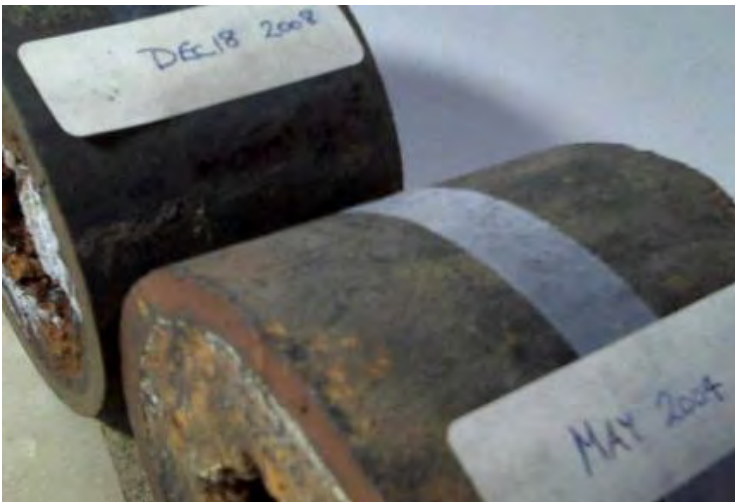
DECEMBER, 2008

MAY, 2004

4.5 Years of Using SeaQuest 100 Years of Occasional Caustic

3. The hole in their Pipe increased from ½" to about 2" (two inches). Chlorine residuals remained stable using about 29% less Chlorine Gas and Flushing Time was greatly reduced from Twice a Year down to Once a Year and for about only 20 minutes per Hydrant. When you add it all together; Staff Time, Equipment, Paper Work, Water Usage, etc., **SeaQuest saved Stellarton much more than the cost of using our product!**

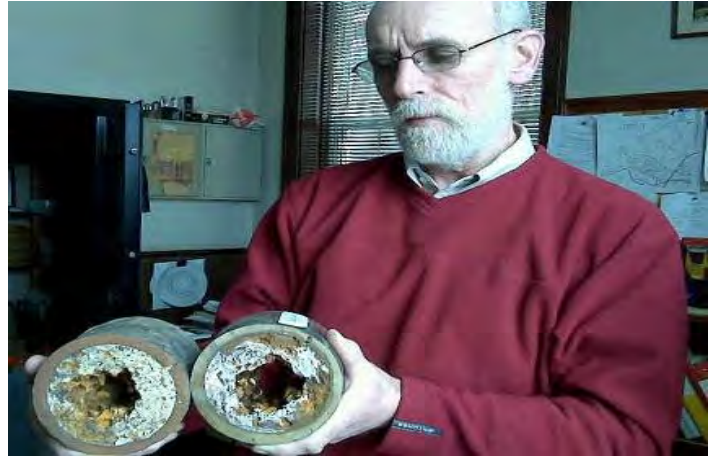
Tony Addis, Town Engineer Inspecting Both Pipes

2. Unexpectedly, in December, 2008, 4.5 years later, a pipe break occurred about 100 feet from the original piece of cut out pipe. The Pipe in the above picture in Tony's left hand was a result of 4.5 years of cleanout from using SeaQuest. The Town of Stellarton was already saving money with less Chlorine Usage and dramatically decreased Flushing (cut by half), but now they were amazed at what they actually saw in their Pipe!

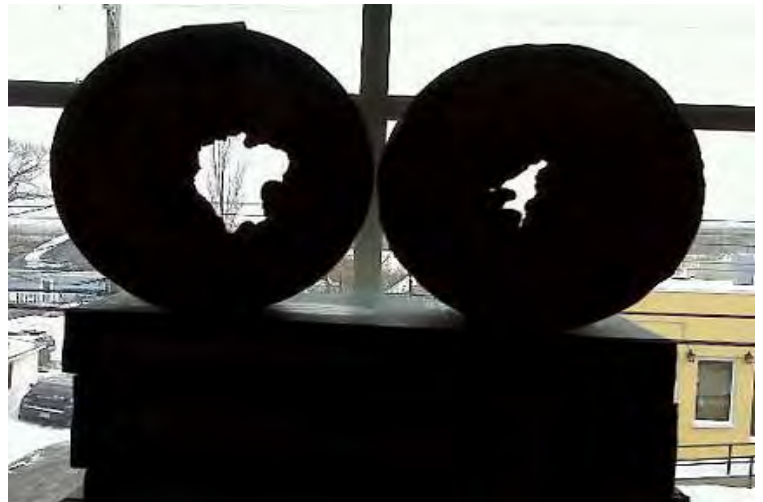
4.5 Years of Using SeaQuest compared to 100 Years

- 1. 100 Year Old Pipe - Opening from ½" To 2" (300% Increase)**
- 2. Chlorine Gas Usage was Reduced by 29% while Residuals remained stable throughout the Town of Stellarton.**
- 3. System Wide Flushing went from Twice a Year to only Once a Year (50% Less Staff and Equipment Flushing Time).**
- 4. Flushing Hydrants went from about 1 hour down to about 20 minutes before the water clears (Flushing approximately 66% less water!)**
