Drinking water 2015

Public water supplies in the London and South East region of England

A report by the Chief Inspector of Drinking Water

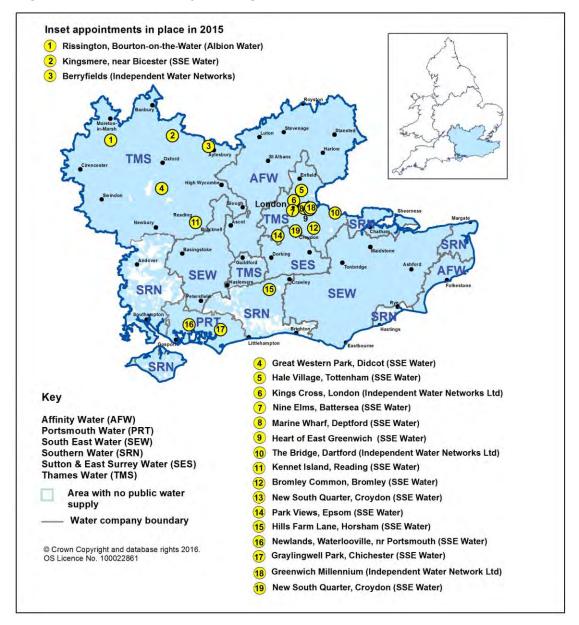
Figure 1: Water supply arrangements

Set out in this report are the key facts about the quality of the public water supplies in the London and South East region, which is served by nine water companies delivering supplies to 18,926,936 consumers. The area served by each water company is shown in Figure 1 and the organisation and nature of water supplies in the London and South East region is described in more detail in Chapter 2. There were no changes in the water supply arrangements in the region in 2015 compared to 2014.

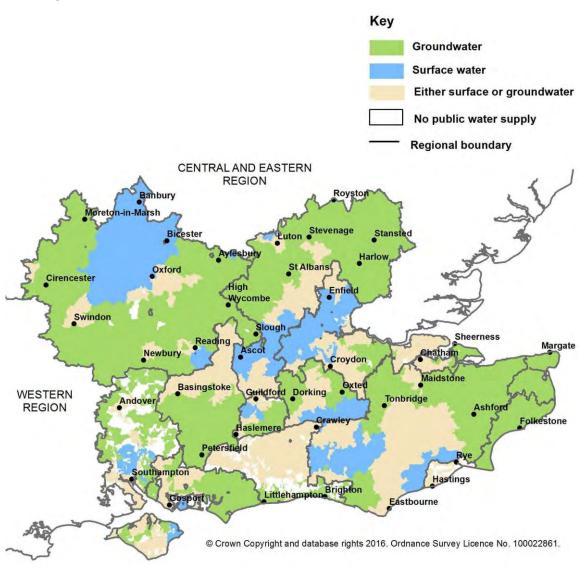
Figure 4: Map illustrating sources of drinking water by zone across the region

Nine water companies supply drinking water in the London and South East region: Affinity Water (AFW); Portsmouth Water (PRT); South East Water (SEW); Southern Water (SRN); Sutton and East Surrey Water (SES); Thames Water (TMS); and three inset appointees, SSE Water (SSE), Independent Water Networks Ltd (IWN) and Albion Water (ALB).

As shown in Figure 4, Independent Water Networks Ltd supplies water to the Bridge in Dartford, Berryfields in Aylesbury, the Kings Cross development in London and the Millennium Village in Greenwich, London. SSE Water supply water to insets in Hale Village in Tottenham, London; Kennet Island in Reading; Bromley Common in south east London; Park Views in Epsom; Graylingwell Park, Chichester; Great Western Park, Didcot; Kingsmere in Bicester; New South Quarter in Croydon; Marine Wharf, Deptford, southeast London; Heart of East Greenwich, London; Hills Farm Lane, Horsham; Nine Elms, Battersea in London; and Newlands, Waterlooville, near Portsmouth. Albion Water also supplies 1,183 consumers in Upper Rissington, near Bourton-on-the-Water in Gloucestershire.

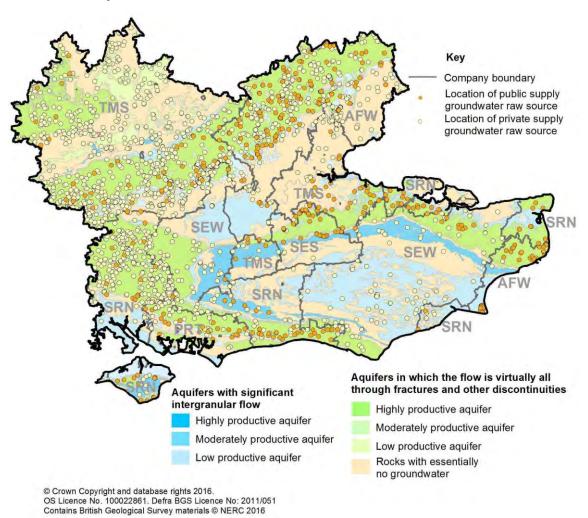
Figure 5: Location of private and public supply groundwater abstraction points

Figure 5 illustrates the location of private and public supply groundwater abstraction points in relation to the groundwater aquifers in the region.

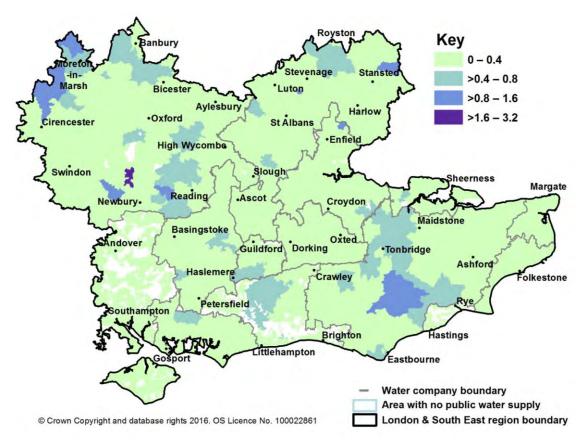
Figure 14: Map illustrating rates of chlorine-related consumer contacts to water companies per 1,000 population

recording contacts from consumers reporting chlorine-related tastes or odours in tap water. Figure 14 maps the chlorine taste and odour consumer contact rate per 1,000 population for all zones in the London and South East region during 2015.

From Figure 14 it can be seen that consumers in Thames Water's Brightwalton zone near Newbury exhibit a relatively high rate of reporting chlorine-related tastes and odours (>1.6 per 1,000 population) and this is well in excess of the industry average of 0.2 per 1,000 population. This information will be taken into account during the Inspectorate's forward programme of technical audit in the region.

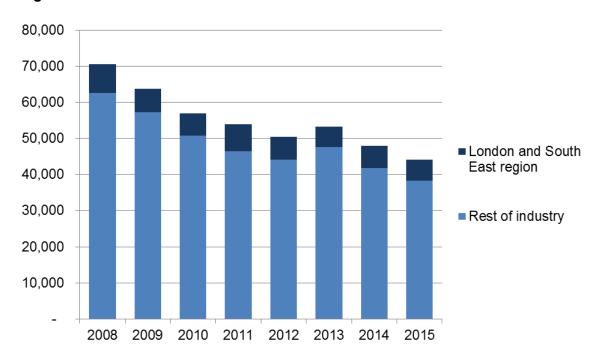
Figure 18: Total contacts for discolouration 2008-2015

Discolouration of tap water often prompts consumers to contact their water company. The number of people contacting water companies about discoloured water is reported annually to the Inspectorate in accordance with Information Letter 1/2006. Looking at the trend since 2008, it can be seen from Figure 18 that across the industry, the numbers of consumers contacting their water company to complain about discoloured water has fallen from 70,648 to 44,141 in 2015. Between 2014 and 2015 in the

London and South East region, the situation is similar to last year with the figure now standing at 5,918, down from 6,131 in 2014. Overall the region accounts for 13% of all consumer contacts for discolouration across England and Wales.

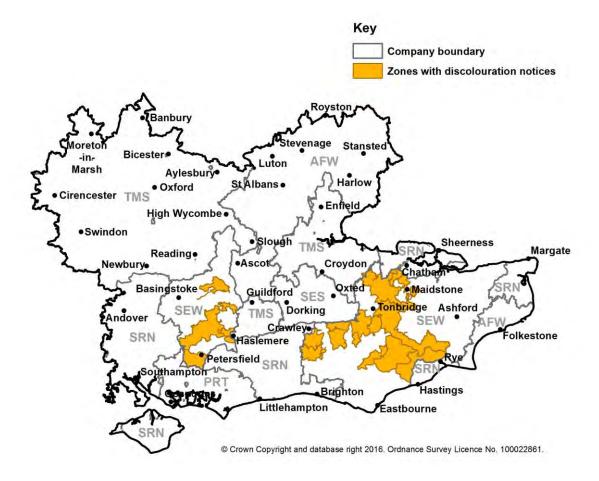
Figure 19: Zones where notices have been served to address discolouration

From the review, one company was identified as being in the London and South East region, (SEW). South East Water as part of their company programme, paln to dose with SeaQuest at Crowhurst Bridge, Pembury, Arlington, Forstal, Barcombe, Bewl and Keleher works which supply 17 zones, all identified as having high discoloration contact in this exercise. SeaQuest is blend of polyphosphates and orthophosphates added to the water which reduces discolouration and corrosion by keeping metals in solution. In addition to this strategy, the company has adopted a flushing programme to tackle the discolouration contact rates and associated metals failures. In order to ensure the full delivery of these programmes, the Inspectorate has initiated enforcement action in the form of zonal Regulation 28 Notices in the 20 zones shown in Figure 19.
