Field Trial of SeaQuest in the City of Atlanta

Based on a successful pipe loop and corrosion coupon test, the City of Atlanta initiated a field trial of SeaQuest to determine the potential for cleanup of several areas of highly corroded pipe.

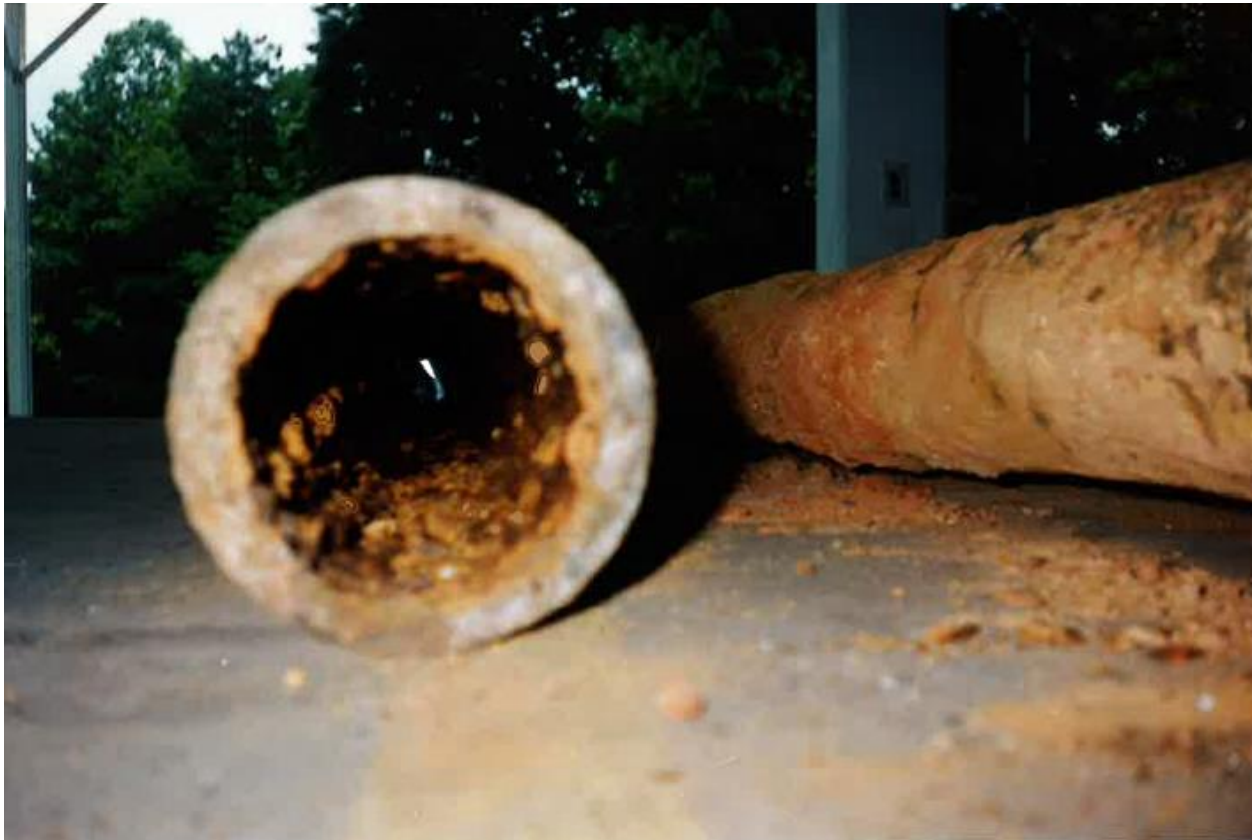
Three twelve foot sections of 6” diameter pipe, which had been in service for several years, were removed and used for the field evaluation. The interior of the pipes showed significant corrosion tubercles and scale buildup as seen in Image 1.

Image 1: Heavily corroded pipe previously treated with zinc ortho phosphate

To evaluate Seaquest, we obtained three twelve foot sections of 6" diameter pipes which had been in service for several years. The interior of the pipes was completely covered with tubercles formed by various components such as trace metals, calcium carbonate build-up etc. Much of the build-up exceeded 1/2". Two of the pipes were connected and one was held as a "Before". Since we had no practical way to obtain filtered water which had no addition of phosphate compound, we used river water for the test. Seaquest was added at 1 mg/l and a trace of chlorine was added to prevent bio-mass formation. The flow rate was 44 gpm.

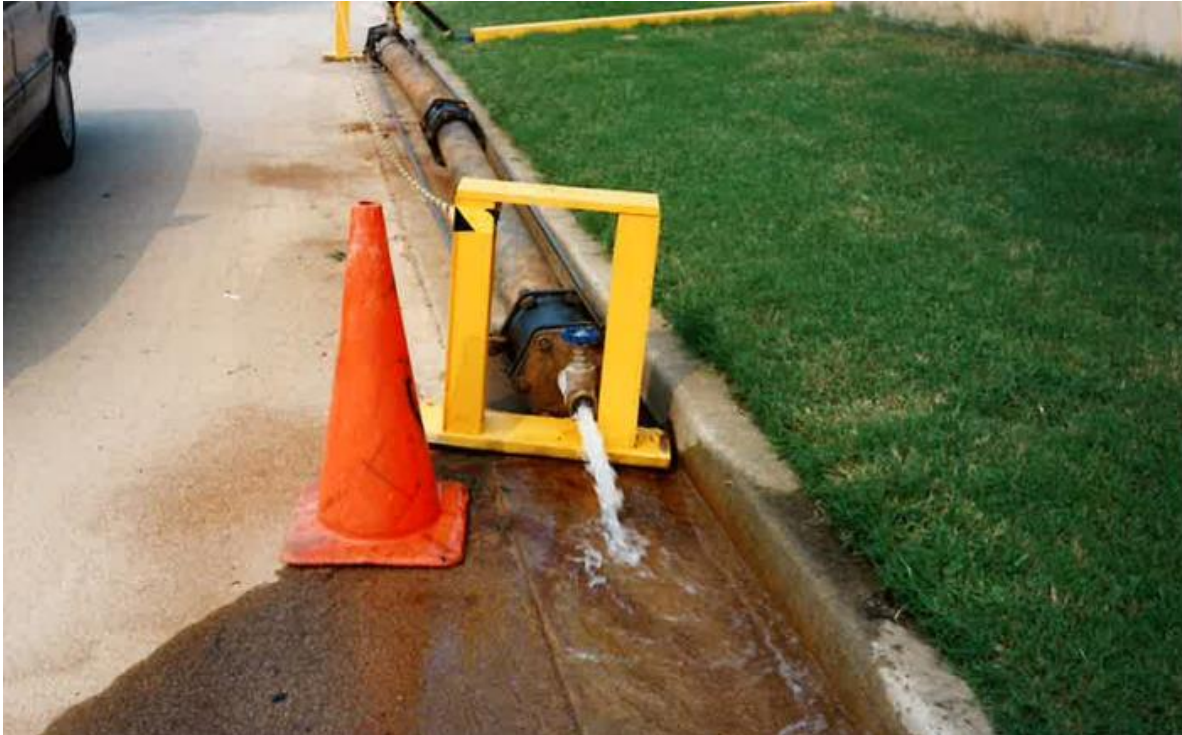
River water was treated with both SeaQuest and chlorine, and the water was fed as a single pass through each pipe. The flow rate was 44 gpm and SeaQuest was dosed at 1.0 ppm. The test was performed for 9 weeks. During the entire duration of the test, the “effluent” water remained clear, as seen in Image 2.

Image 2: Clear water observed during 9 week trial

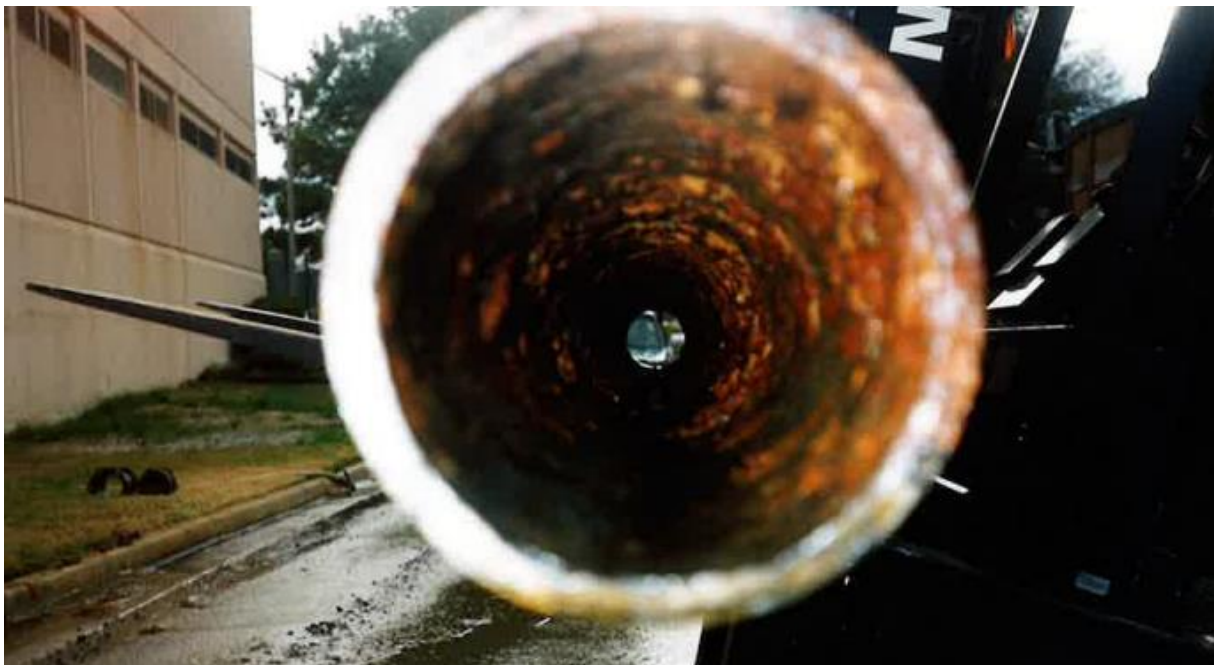
At the end of the test the pipes were inspected, and roughly 90% of the corrosion tubercles and scale was removed as seen in Image 3.

Image 3: Clean pipe treated with SeaQuest

During the 9 weeks of the test, the effluent from the pipes appeared clear. When the pipes were opened and the sediment flushed out, it appeared that about 80 - 90% of the deposits were removed. About 30% of the original pipe wall was exposed and clean. A large amount of sediment in the pipe was settlement of the turbidity particles from the river water. The effluent valve connecting nipple and gate valve were rusted on the upper portions where no water was contacting the insides. The lower walls in contact with the water were clean and devoid of rust.
